HIGHWAY RESEARCH REPORT

DYNAMIC TESTS OF AN ENERGY ABSORBING BARRIER EMPLOYING SAND-FILLED FRANGIBLE PLASTIC BARRELS SERIES XXIV

RESEARCH REPORT

NO. M & R 636405-4

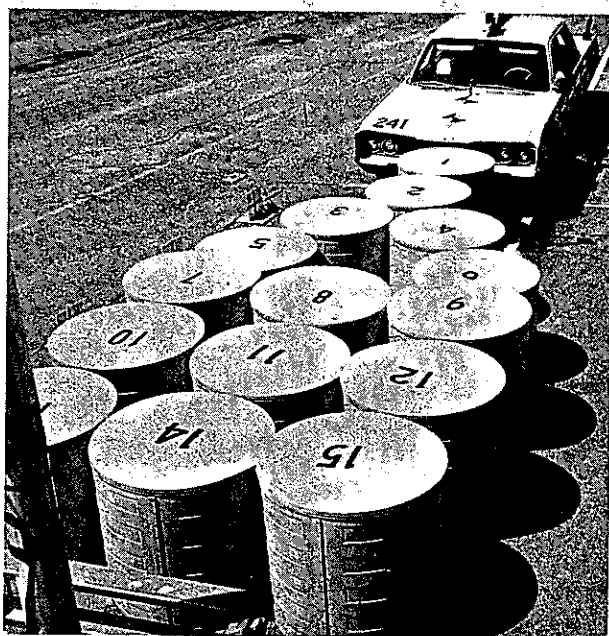
FIGURE 3

The barrier was constructed using barrels containing 400 lbs. of sand at the nose and 2100 lb. barrels at the rear (see Exhibit I and Figures 3 and 4). This mass gradation was designed to obtain a relatively uniform rate of deceleration during impacts. The barrier had a width of 3' (one barrel) at the nose and was tapered out to a width of 9' (three barrels) at the rear.

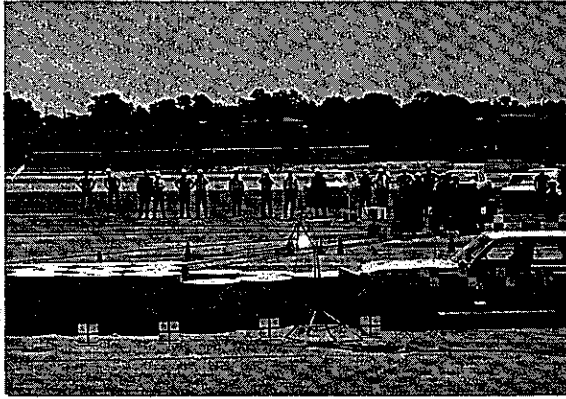
Impact + 0.027 Sec.

Impact + 0.231 Sec.

Impact + 2.373 Sec.

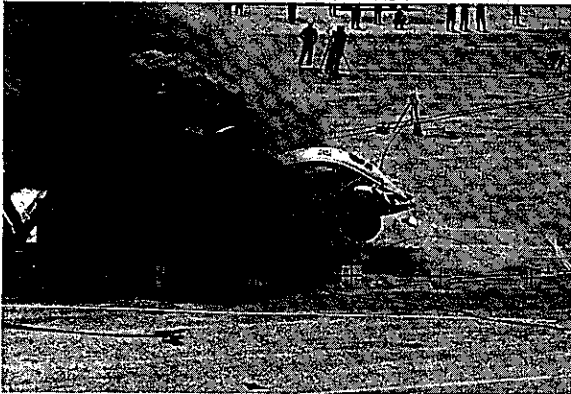
Impact + 0.022 Sec.

Impact + 0.163 Sec.

Impact + 0.586 Sec.

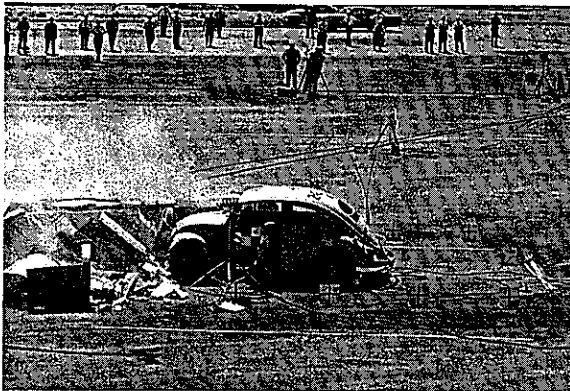
Impact + 4.536 Sec.

Deceleration Distance - Passenger Compartment	19'-0"	Test No.	242
Maximum Vehicular Deformation at Forestructure	8"	Date of Test	September 4, 1970
Passenger Compartment Deceleration -		Vehicle	1957 Volkswagen Sedan
Highest 50 ms. avg. - Accelerometer		Vehicle Weight	1940 lbs.
Record, 176 Hertz	8.7 G's	(w/dummy & instrumentation)	
Vehicular Deceleration = Avg. value		Impact Velocity (V_o)	59.0 mph
based on $V_o^2 = 2as$ where $s = 19.0'$		Impact Angle	Head-on
(stopping distance)	6.1 G's	Dummy Restraint	Lap belt
Gadd Severity Index (Dummy's head)	1280	Barrier Depth	25'-3"
		No. of Plastic Barrels	17

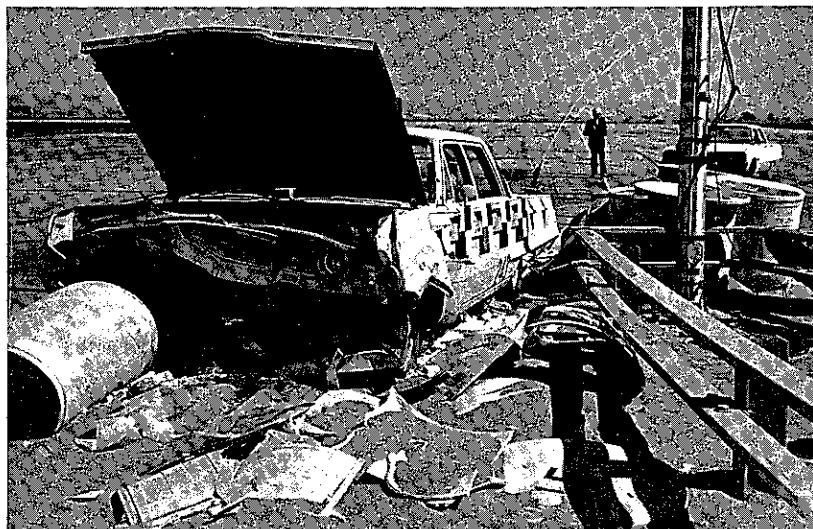
FIGURE 19

Damage to the vehicle forestructure was quite severe (Figure 19). The front end, including fenders, was uniformly crushed back against the engine. The maximum crush was 1'-9" (Exhibit 3). The engine was not displaced. The lower longitudinal front frame members and the bumper were sharply buckled down to the ground and back against the front wheels. The hood was undamaged due to the relatively low 30" height of the first four rows of barrels. A crimp in the roof was observed on the driver's side above the doorpost. The rest of the car including the windshield, was undamaged.

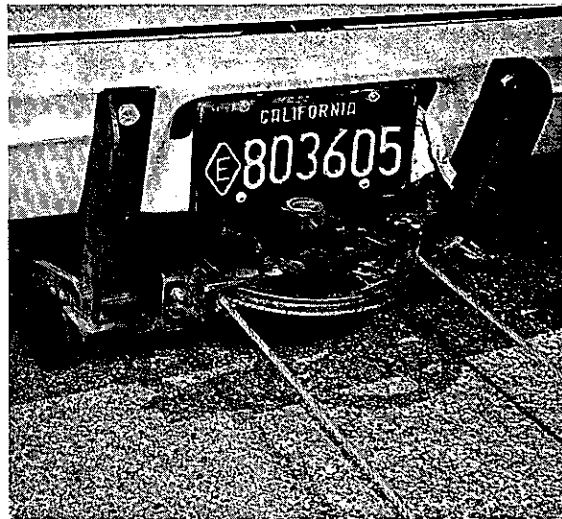
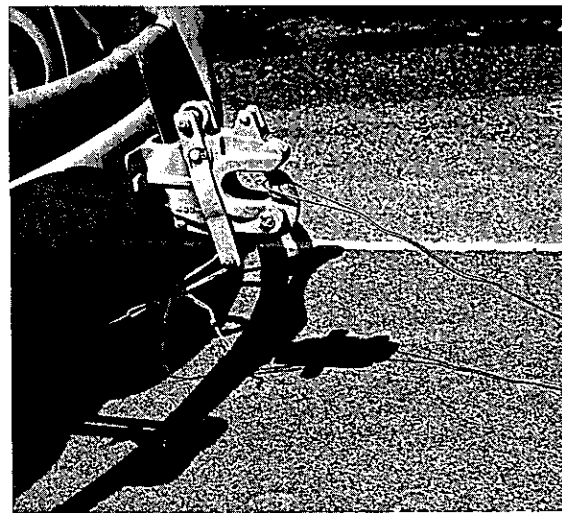
A linear actuator was used on the tow vehicle accelerator to keep the acceleration smooth and constant and to insure an impact velocity of the VW near 60 mph based on trial runs which were used to calibrate the actuator.

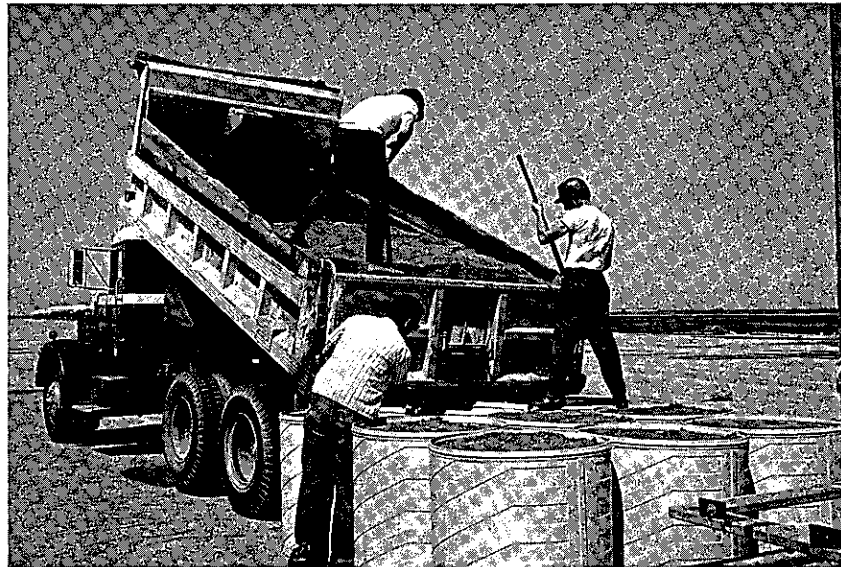
FIGURE C-1

The sand (about ten tons) was delivered in one large dump truck which had a small guillotine type opening in the middle of the tailgate (see Figure C-1). The truck was positioned for each barrel, the truck bed raised, and the sand guided through the narrow tailgate opening. Two men moved sand in the truck bed and the third man spread the flowing sand evenly in the barrel. There was virtually no spillage of sand with this method

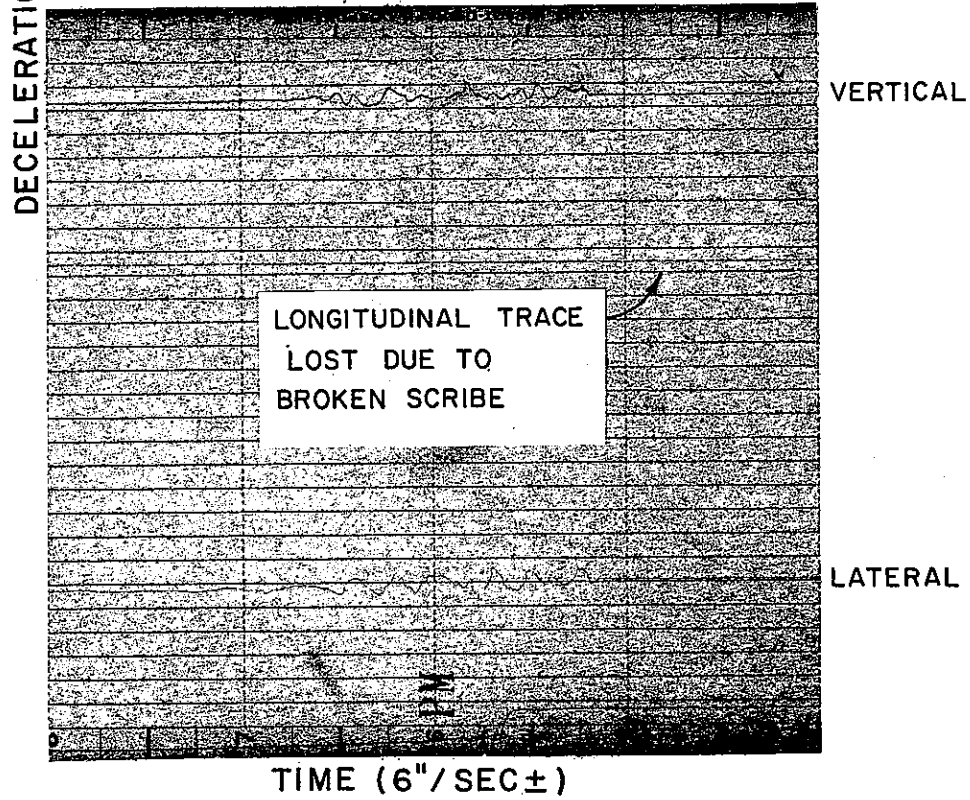
TEST 243
(57 MPH 15°
AT NOSE)
